## TIME OF SALE OSS INSPECTION REPORT

Application No: 172856

16224 195TH PL NE  
KING COUNTY, WA

## SEWAGE DISPOSAL DESIGN AND PLOT PLAN

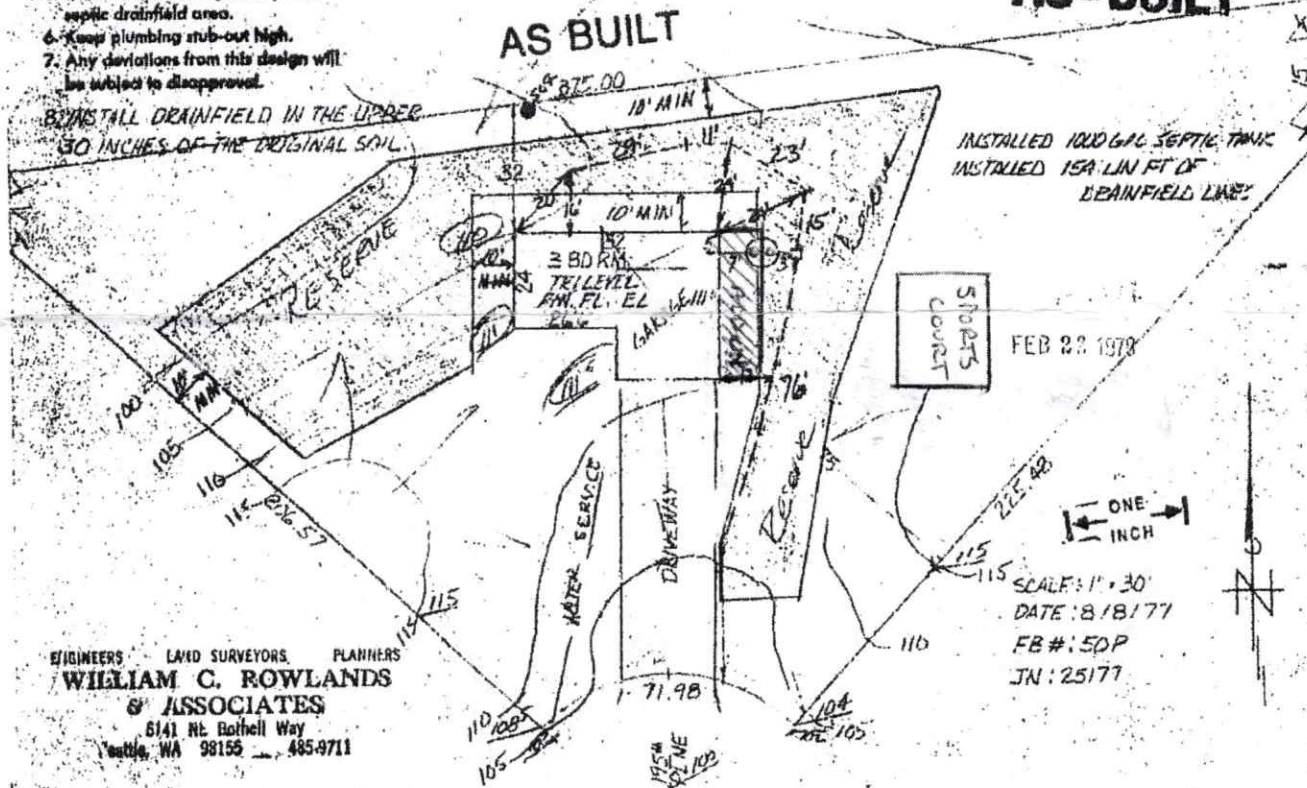
AS-BUILT

REVIEWER - 7/30/2026 - Property Transfer report indicates septic tank is partially under an unpermitted addition to the house. This is a safety issue as poisonous septic gases can enter the home. To ensure adequate treatment of sewage, this system must be connected to sewer, or an approved repair proposal must be obtained, and repair must be installed under permit to the Health Department by a licensed Master Installer.

Tank was pumped 2025  
Addition encroaches over septic tank. Access to first compartment is inside the addition. The second compartment is outside the addition and is 20" deep. See 2025 site sketch
