TIME OF SALE OSS INSPECTION REPORT

18020 214TH AVE NE
KING COUNTY, WA

Inspection Type: PROPERTY SALE - Correction Status: All corrections made

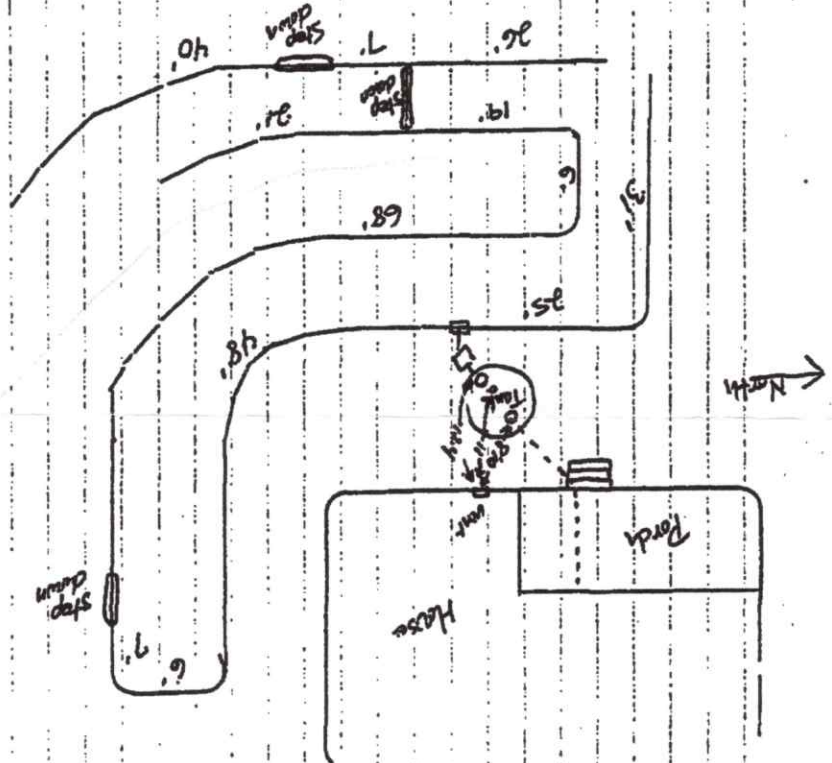
AS BUILT

Tank 7'6" Straw House
Drain field 304'
