## NOTICE TO BUYER: SELLER-PROCURED INSPECTION REPORT

The following notice is given with respect to the Purchase and Sale Agreement dated \_\_\_\_\_  
between \_\_\_\_\_ ("Buyer")  
and **Tony Patricelli** **Kristi Patricelli** ("Seller")  
concerning **2711 169th St SE Bothell WA 98012** ("the Property").

**Kristi and Tony Patricelli  
2711 169<sup>th</sup> St SE  
Bothell, WA 98012**

**Per the seller, the following items listed on the pre-sale inspection summary dated Sept 8, 2026 are being corrected by the seller as part of preparation for sale in good faith.**

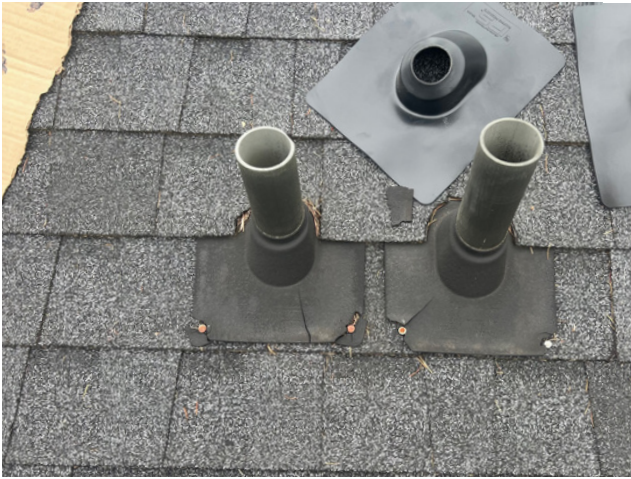
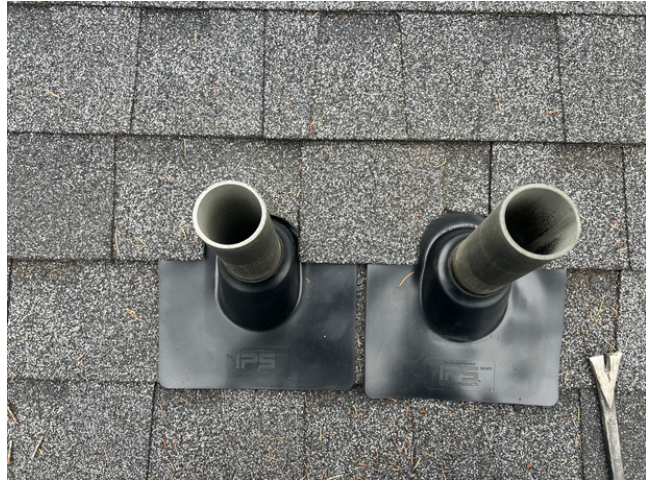
## Cracked plumbing boot - Replaced

4.5.1 Cracked Plumbing Boot – replaced

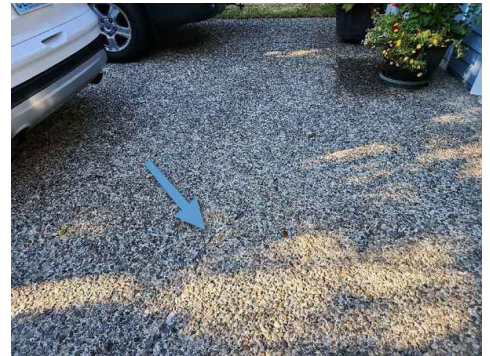
#### DRIVEWAY CRACKS - MINOR

Minor cosmetic cracks observed in the driveway which may indicate movement in the soil. Recommend monitoring and/or have concrete contractor patch/seal.

Contact a qualified concrete contractor.

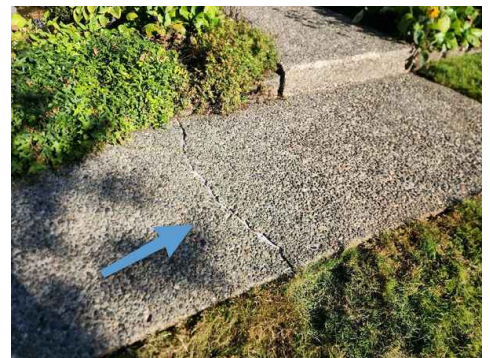
### 3.2.2 Driveways, Walkways, and Patios

#### WALKWAY CRACKING - MINOR

Minor cracks observed at the walkway which may indicate settlement of the underlying soils. I recommend monitoring and/or patch/seal as necessary.

Recommend monitoring.

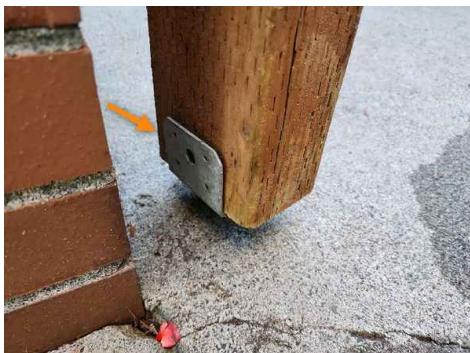
### 3.3.1 Decks, Porches, and Stairs

#### PATIO OR PORCH COVERING - NON PROFESSIONAL

The roof installation did not appear to be built to modern building standards. Examples of concerns will be noted in the photo captions. Contact a qualified handyman or contractor as desired for repair or improvement.

Post Bases not fully fastened

Contact a qualified general contractor.

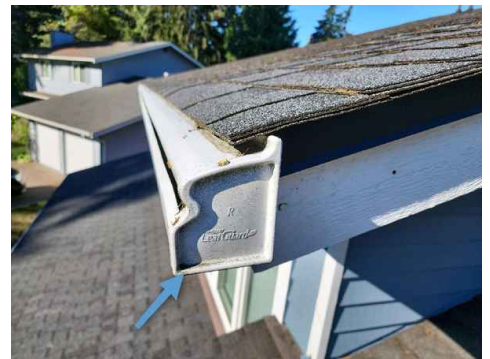
Debris guards installed at the gutters. Unable to view condition of gutter as a result. We recommend maintaining the debris guard as per manufacturers instructions.

Contact a qualified professional.

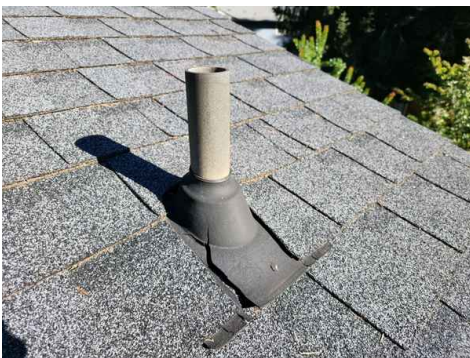
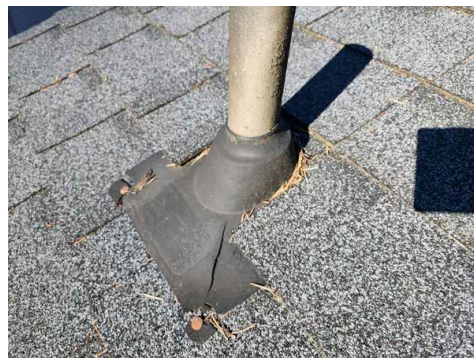
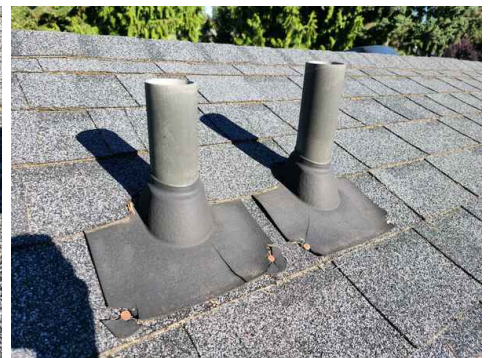
#### 4.5.1 Skylights & Other Roof Penetrations

##### **CRACKED PLUMBING BOOT**

One or more rubber plumbing boots were cracked. I recommend evaluation and repair/replacement as needed by a qualified roofing contractor to prevent moisture intrusion.

Contact a qualified roofing professional.

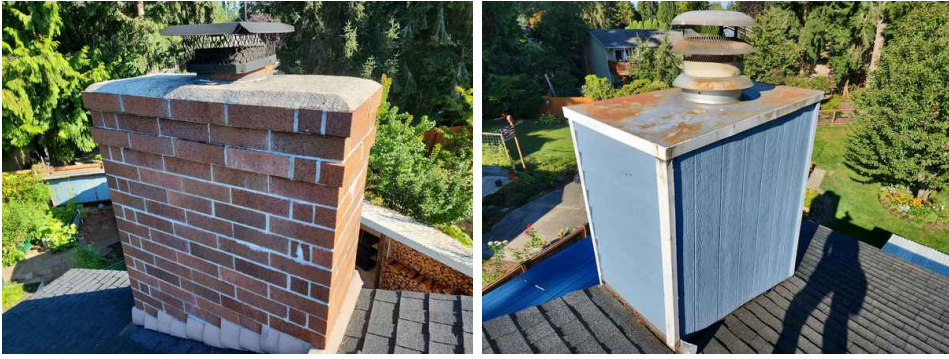
#### 5.1.1 Chimney

##### **CHIMNEY MAINTENANCE**

Regular chimney maintenance is recommended as part of any normal homeowner maintenance routine. We recommend having the chimney and/or fireplace system cleaned and serviced annually, by a qualified chimney sweep professional. Examples of any needed areas of maintenance will be noted in the photo captions.

Contact a qualified chimney sweep.

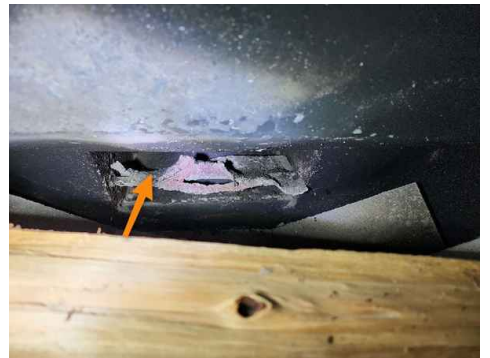
### 5.2.1 Fireplace **CREOSOTE BUILDUP**

There was a notable amount of creosote buildup in the flue. Recommend a qualified fireplace or chimney contractor inspected and sweep on annual basis.

Right Side Fireplace

5.2.1 Creosote Buildup

Contact a qualified fireplace contractor.

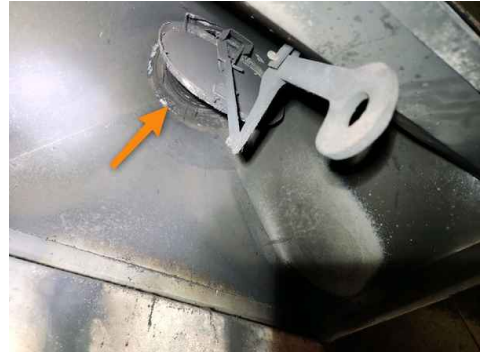
### 5.2.2 Fireplace **DAMPER OPERABILITY**

The damper appeared to be non-operable or partially operable at time of inspection. We recommend a qualified chimney sweep evaluate for repairs prior to use.

Left Side Fireplace

Contact a qualified chimney contractor.

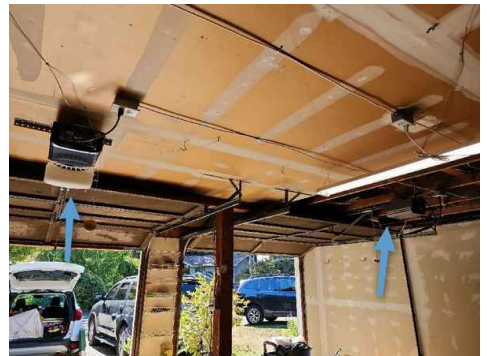
### 6.2.1 Garage Door/Garage Door Opener **MAINTENANCE**

The garage door and/or garage door opener appeared to be in need of normal service or regular maintenance. Examples of observations will be noted in the photos below. This is regular homeowner maintenance for any home. I recommend service and repair as needed by a qualified garage door technician.

Contact a qualified garage door contractor.

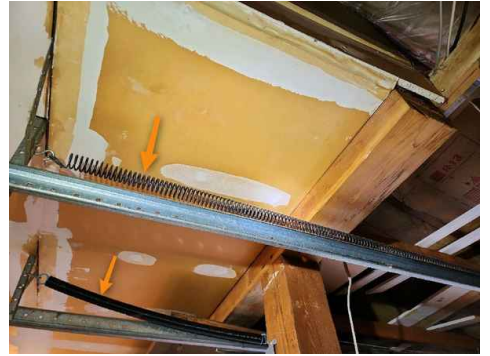
### 6.2.2 Garage Door/Garage Door Opener

#### MISSING SAFETY CABLE

The springs at the overhead garage door were missing safety containment cables which are designed to prevent the springs from causing injury in the event that they become detached. I recommend evaluation and repair by qualified garage door contractor.

6.2.2 and 6.2.3 - Replace Garage door opener

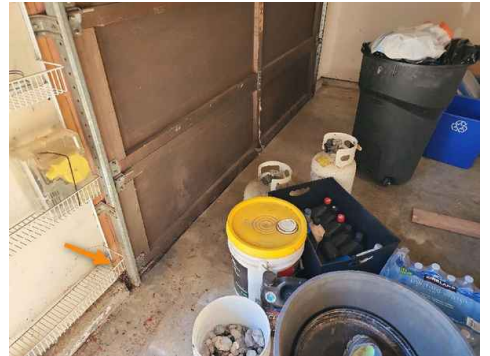
### 6.2.3 Garage Door/Garage Door Opener

#### PHOTO EYES MISSING

The photo eyes are an important safety feature of the garage door opener system. These will help to prevent the door from closing in case of an obstruction which could lead to injury or damage to people or property. The photo eyes need to be installed at the proper height and alignment to function properly and provide protection. Typically these eyes are installed approximately 6" from the floor. The photo eyes here are missing. I recommend installation by a qualified handyman or garage door technician.

Left Side

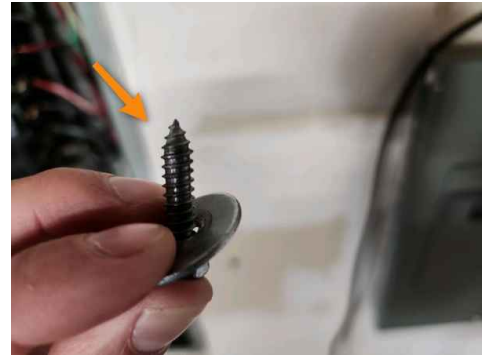
### 8.2.2 Main Electrical Panel and Materials

#### IMPROPER FASTENERS

Improper pointed screws were used to secure the panel cover. Pointed screws have the potential to penetrate the wire insulation and create a safety or fire hazard. Blunt end screws should be used according to the manufacturer specifications. I recommend replacement by qualified electrical professional.

8.2.2 Electrical Panel Fasteners – replaced

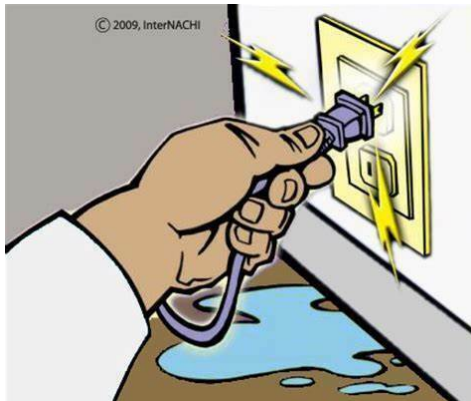
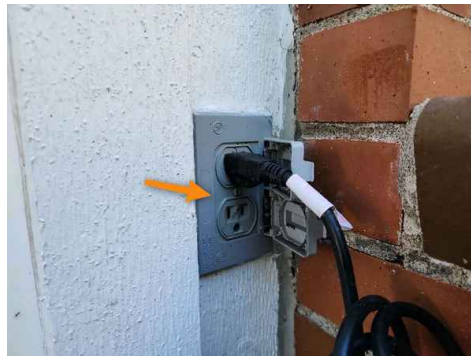
### 8.3.1 Lighting, Wiring, Switches & Receptacles

#### GFCI - RECOMMEND UPDATING

Although not necessarily required when the home was built, we recommend that all outlets in close proximity to water (kitchen, exterior, bathrooms, garage, etc.) be protected by a Ground Fault Circuit Interrupter (GFCI) device. A GFCI is designed to detect an imbalance, or fault, in the electrical current and shut off the circuit before personal injury can occur. GFCI receptacles can be installed at the point of use or whole circuits can be protected at the panel. I recommend a qualified electrician evaluate and update the system as needed.

Exterior Outlets

8.3.1 Outdoor GFCI

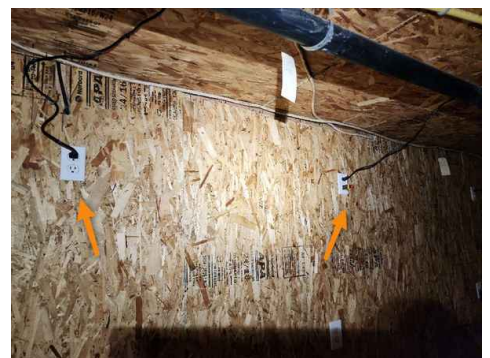
### 8.3.2 Lighting, Wiring, Switches & Receptacles

There did not appear to be power at one or more outlets at the time of inspection. Unknown to the inspector the reason for the condition. I recommend that a qualified electrical contractor evaluate for repair/replacement.

Crawlspace

8.3.2 No Power to Outlet – Power to outlets is on a switch located on the ceiling inside the crawl space door

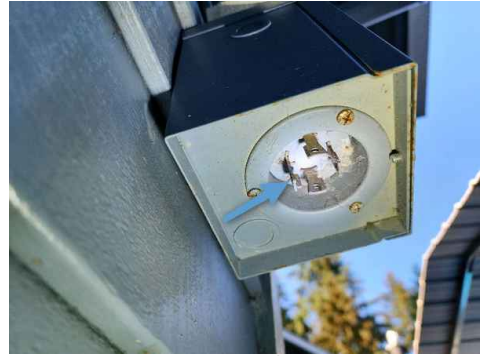
### 8.3.3 Lighting, Wiring, Switches & Receptacles

an outlet appeared to be painted. This may inhibit use of the outlet. I recommend that a qualified contractor clean the connectors.

Paint noted at Rear/Left Side outlet

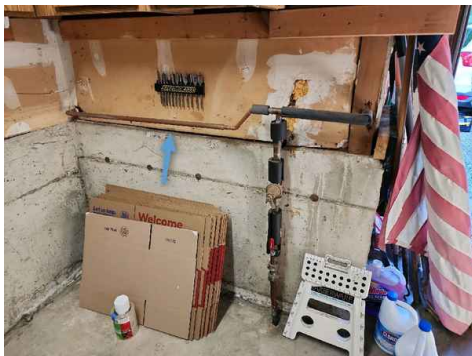
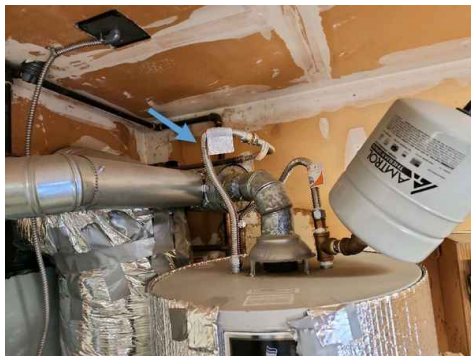
Missing insulation on plumbing pipes in one or more areas. I recommend insulating plumbing lines in all unconditioned areas of the home to prevent freeze potential and or condensation. Generally, this is a simple improvement, that can prevent expensive pipe bursting repairs.

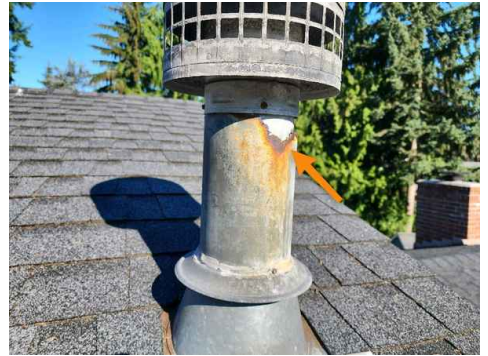
**FLUE DETERIORATION**

It appeared that the flue was rusted and deteriorated at the time of inspection. Recommend a qualified professional evaluate and remedy.

Contact a qualified HVAC professional.

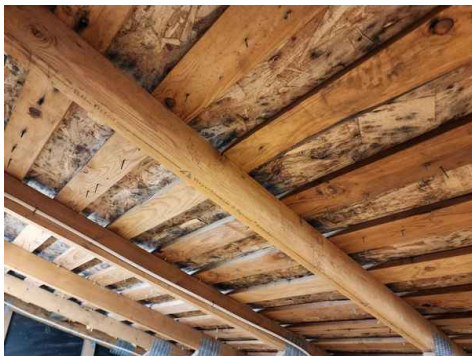
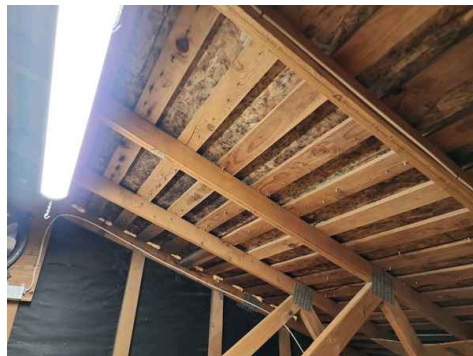
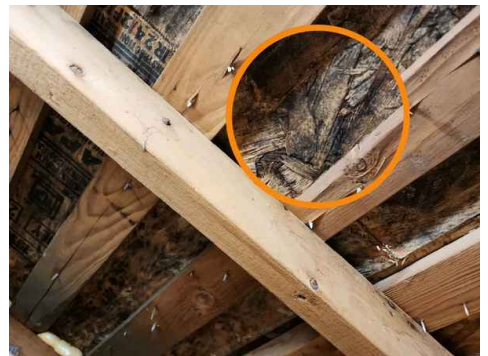
## 15.1.1 Roof Structure and Attic

**APPARENT FUNGAL GROWTH**

Residue observed on attic sheathing appeared to be fungal in nature. I did not inspect, test or determine if this growth is or is not a health hazard. This type of testing is beyond the scope of a standard home inspection. The underlying cause is moisture or dampness. Evaluation by a qualified remediation professional is recommended.

15.1.1 Apparent Fungal Growth – Flapper vent for bathroom fans installed in attic. Area was bleached to kill and remove growth.

Contact a qualified environmental contractor

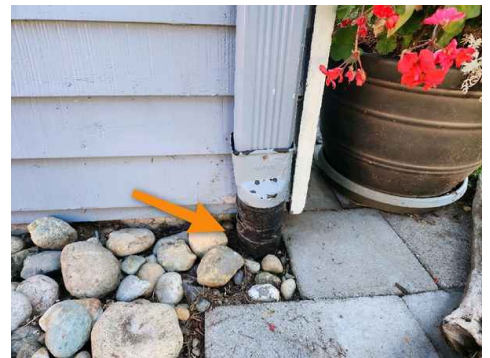
### UNDERGROUND DRAINAGE LIMITATION

Downspout drain

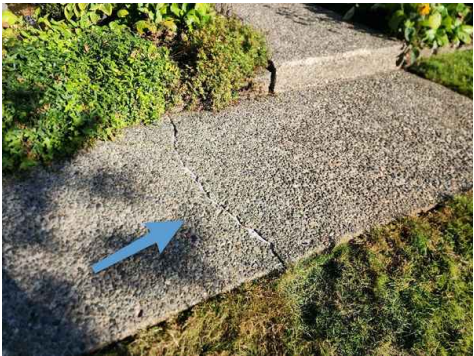
3.2.2 Driveways, Walkways, and Patios

### WALKWAY CRACKING - MINOR

Minor cracks observed at the walkway which may indicate settlement of the underlying soils. I recommend monitoring and/or patch/seal as necessary.

Recommendation  
Recommend monitoring.

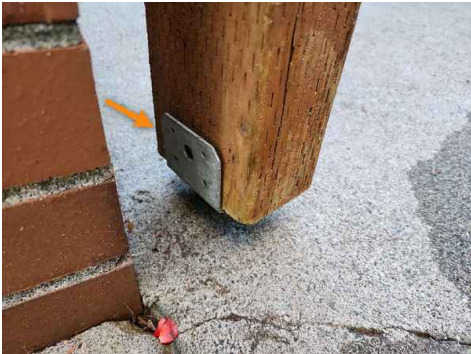
3.3.1 Decks, Porches, and Stairs

**PATIO OR PORCH COVERING - NON PROFESSIONAL**

The roof installation did not appear to be built to modern building standards. Examples of concerns will be noted in the photo captions. Contact a qualified handyman or contractor as desired for repair or improvement.

Post Bases not fully fastened

Recommendation  
Contact a qualified general contractor.

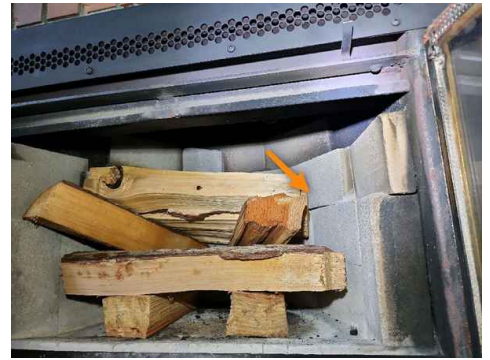
#### **FIREBOX COVERED**

The firebox was covered and therefore not inspected. I recommend evaluation by a qualified fireplace contractor.

Fire bricks appear to be covering steel firebox lining

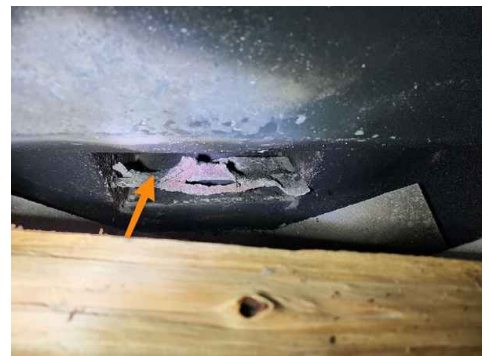
Right Side Fireplace

Contact a qualified fireplace contractor.

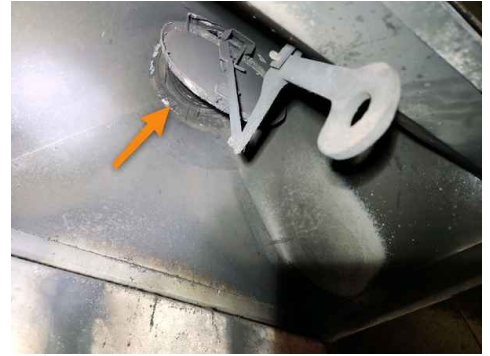
## 5.2.2 Fireplace

Left Side Fireplace

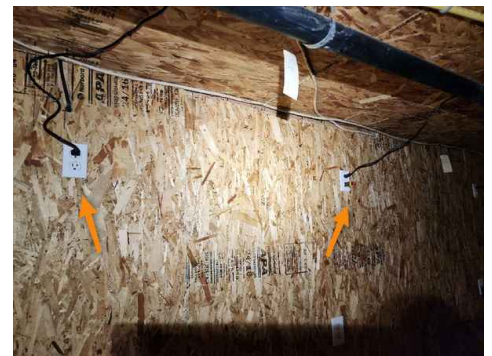
#### 8.3.2 Lighting, Wiring, Switches & Receptacles

Crawlspace

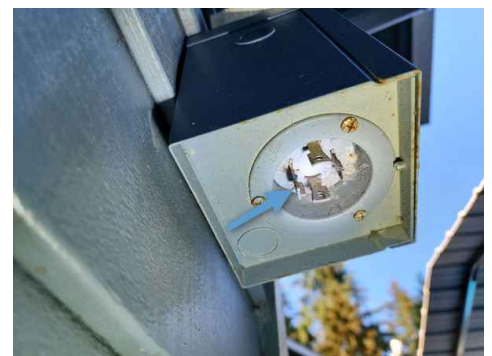
#### 8.3.3 Lighting, Wiring, Switches & Receptacles

Paint noted at Rear/Left Side outlet

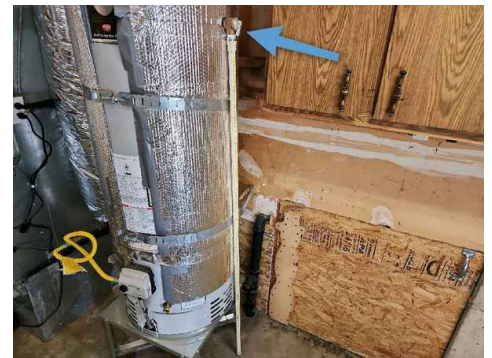
TPR appears to drain to garage slab

Contact a qualified plumbing contractor.

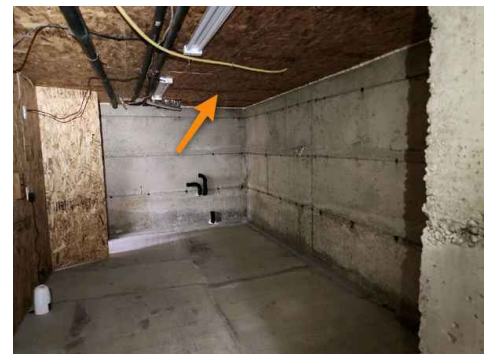
**COVERING INSTALLED ON FLOOR JOISTS**

Coverings were installed on the bottom of the floor joists in one or more areas thereby limiting inspection. I recommend inquiring with the seller about any history or maintenance. For further technical information I recommend evaluation by a qualified contractor.

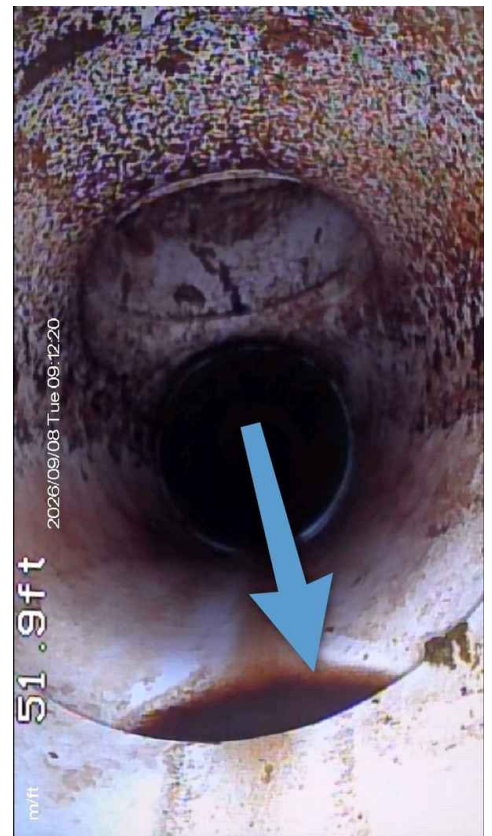
There is an offset joint in the drain/sewer line. Leaks, root intrusions, even cracks and breaks can be effects of offset joints. It is recommended to contact a qualified sewer specialist to monitor or correct these areas.
